**Interpreting Site Formation Processes Affecting Re-emergent Cultural Sites within  
Reservoirs: A Case Study of St. Thomas, Nevada.**

**Master of Arts  
in  
Geography**

**Department of Geology and Geography**

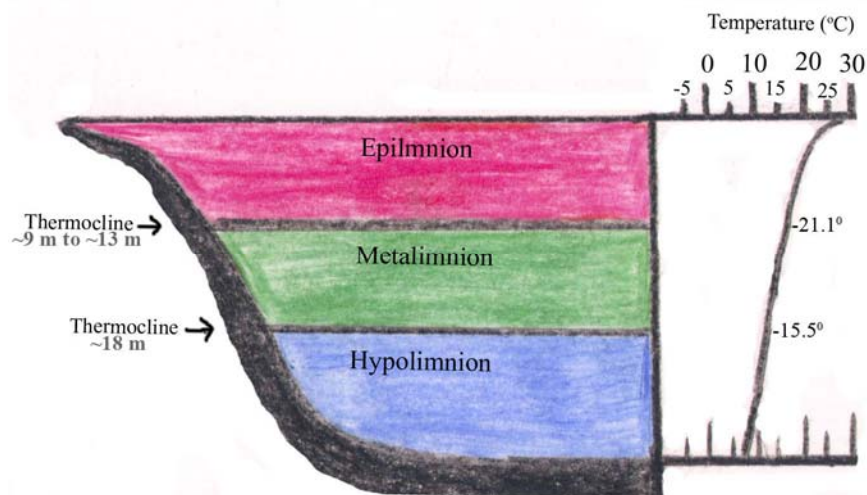
Figure 37: Thermal stratification of Lake Mead during summer months.

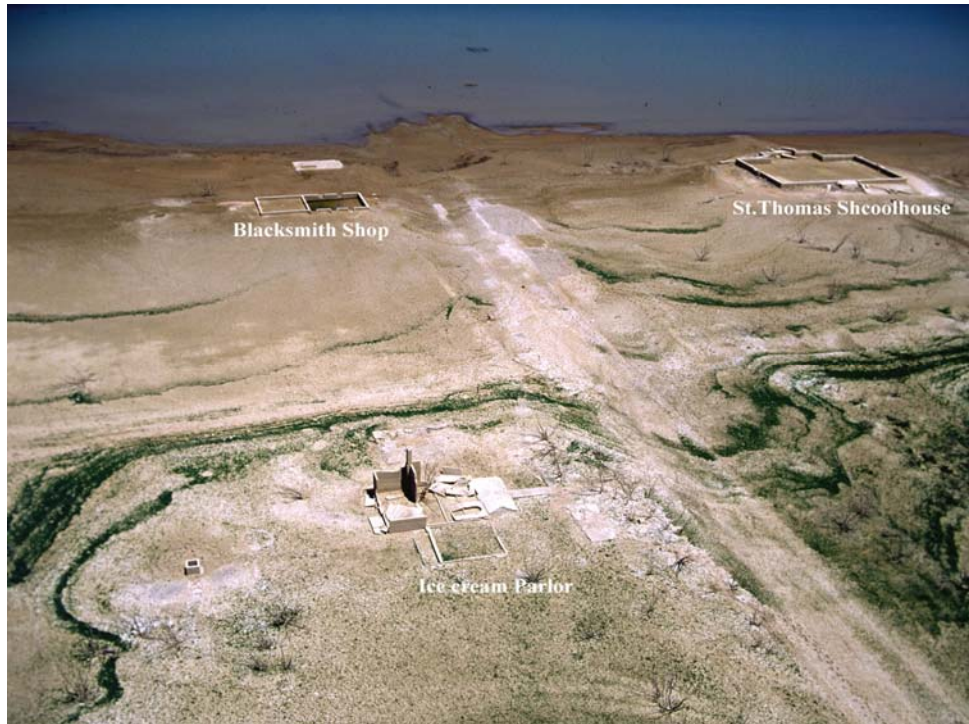
Figure 41: Aerial photo taken June 2003. Re-emergent beach ridges appear as crenulations in the foreshore. Same as figure 42 and 43 but from opposite direction. Photo source: Lake Mead NRA.

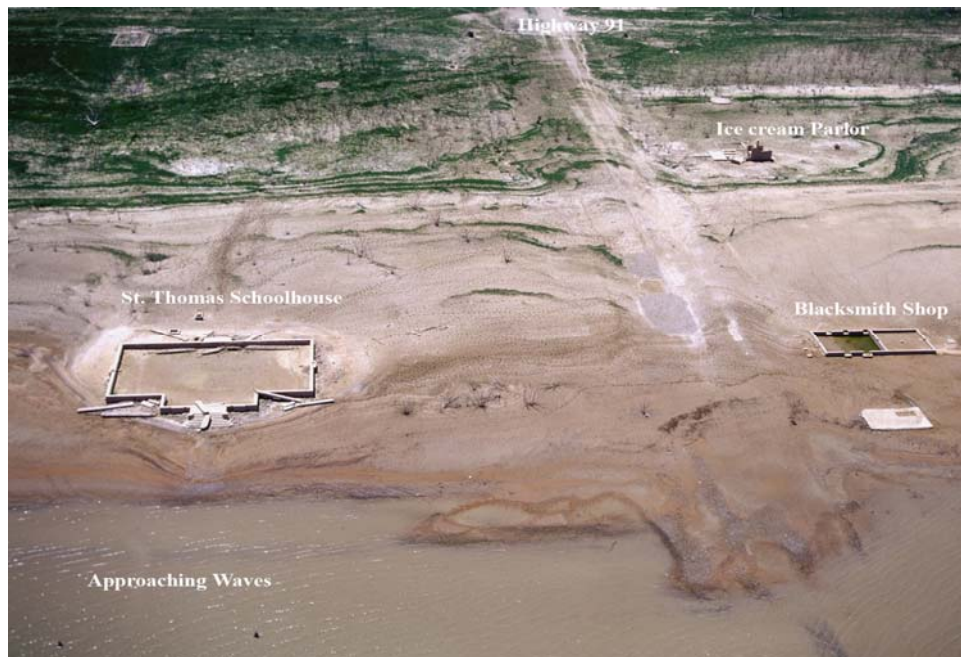
Figure 42: Aerial photo taken June 2003. Re-emergent beach ridges appear as crenulations in the foreshore and note re-emerging structure. Note orientation and direction of approaching waves. Photo source: Lake Mead NRA.

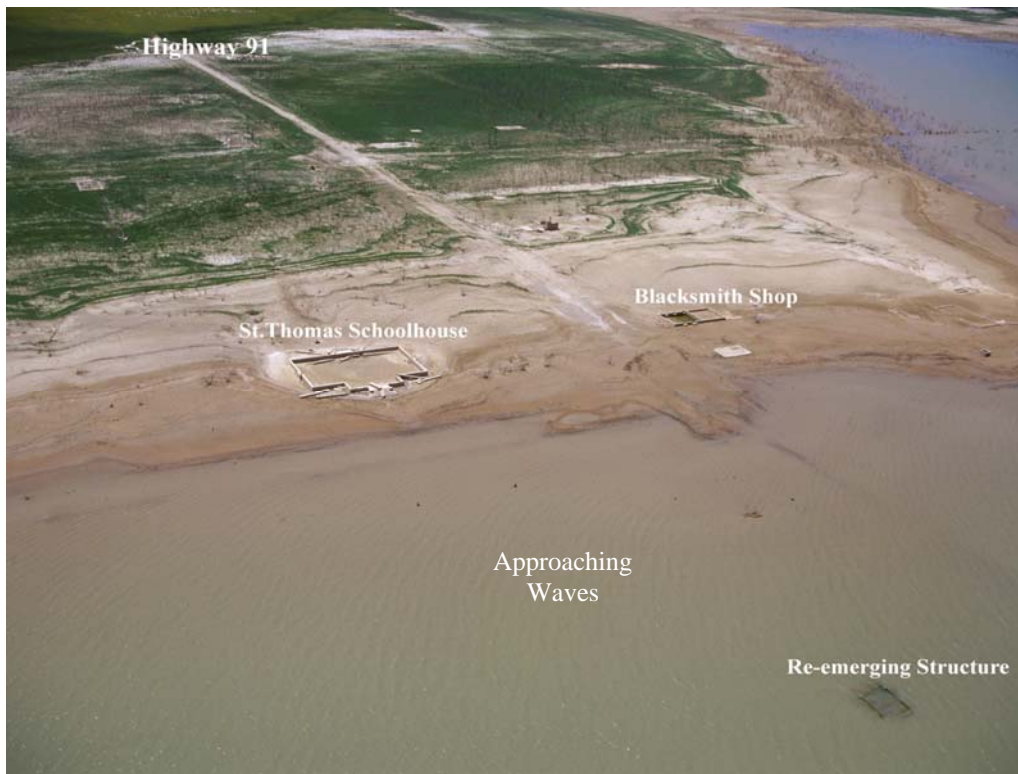
Figure 43: Aerial photo taken June 2003. Re-emergent beach ridges appear as crenulations in the foreshore and note re-emerging structure. Photo source: Lake Mead NRA.

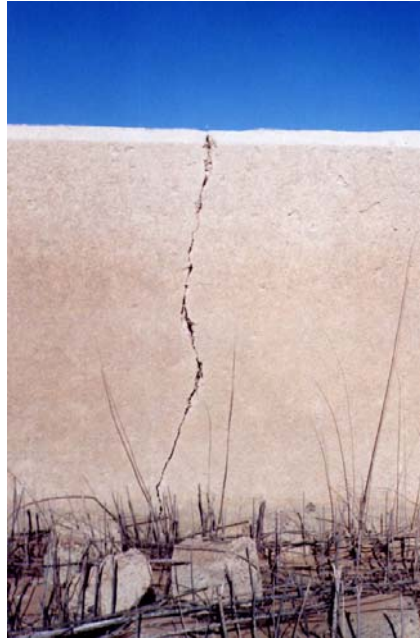
Figure 44: Cracking on St. Thomas Schoolhouse wall. Photo taken January 2006.

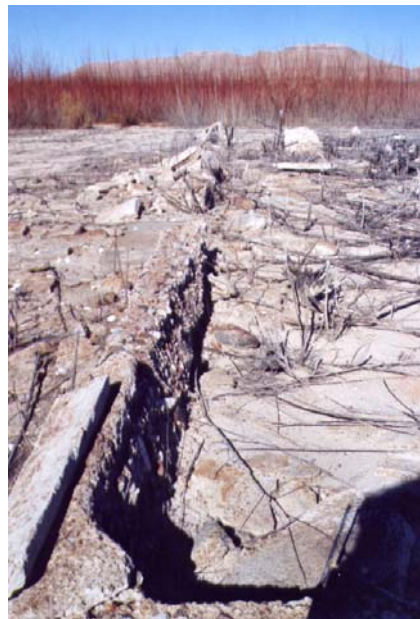
Figure 45: Foundation separation on Gentry Store. Photo taken January 2006.

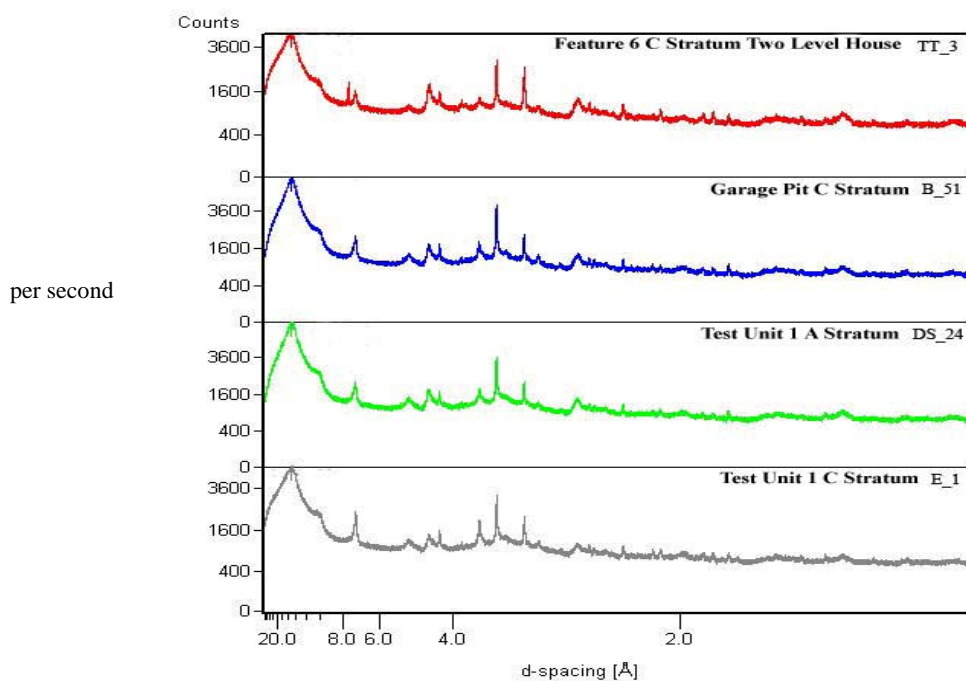
Figure 46: Clay mineral peaks and patterns for four sediment samples. Note similar profile and mineral peaks for each sample.

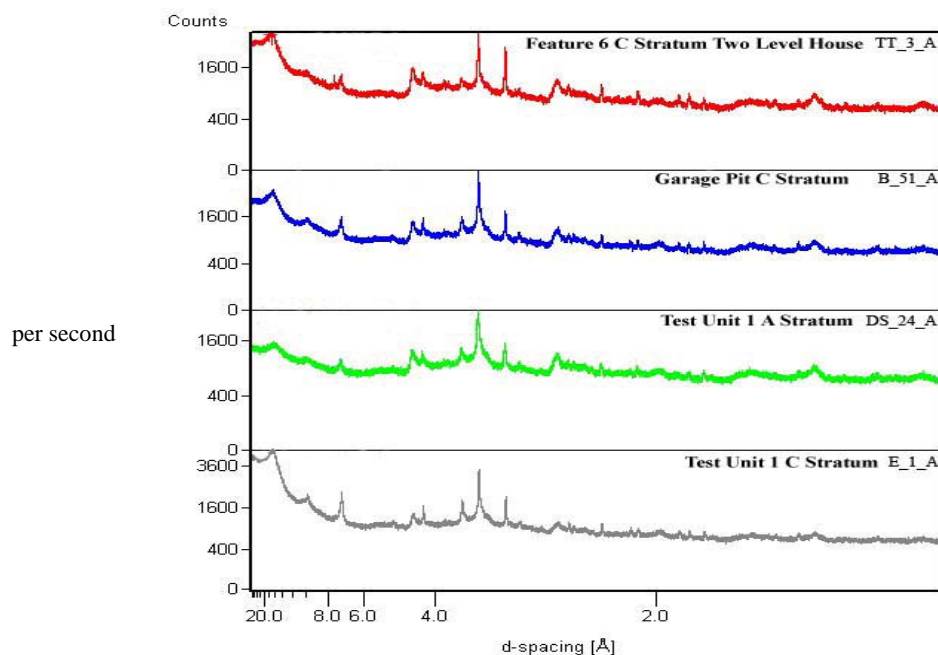
Figure 47: Clay mineral peaks and patterns for four sediment samples after ethylene glycol treatment. Note similar shift in smectite peak in each sample.

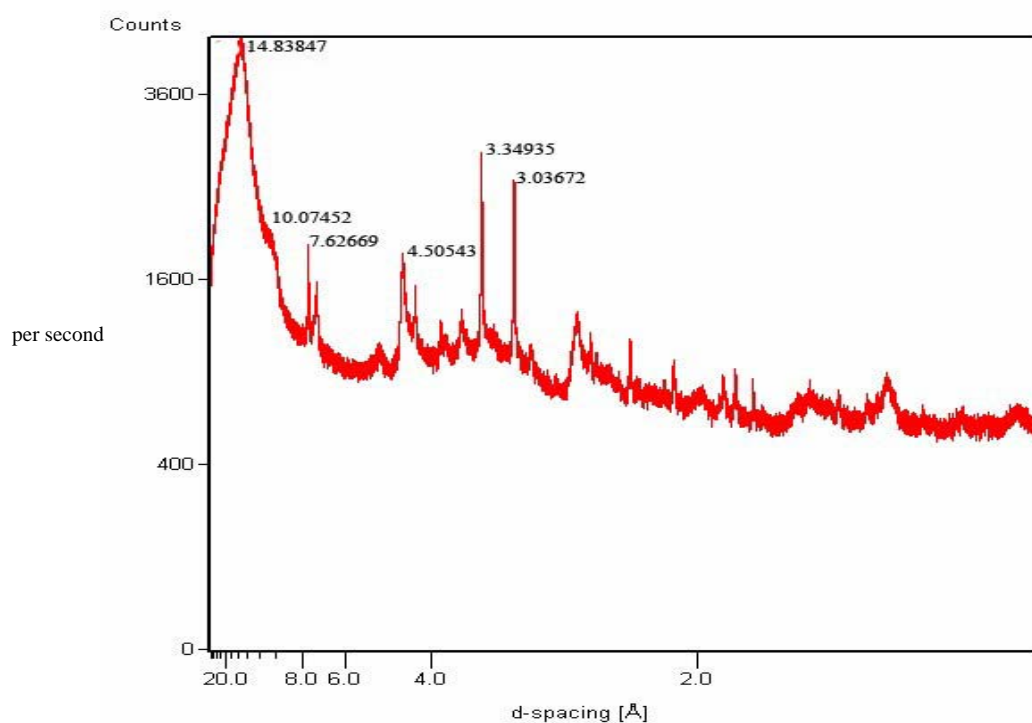
Figure 48: Sample TT\_3, from Feature 6, d-spacing and peaks for identified minerals.

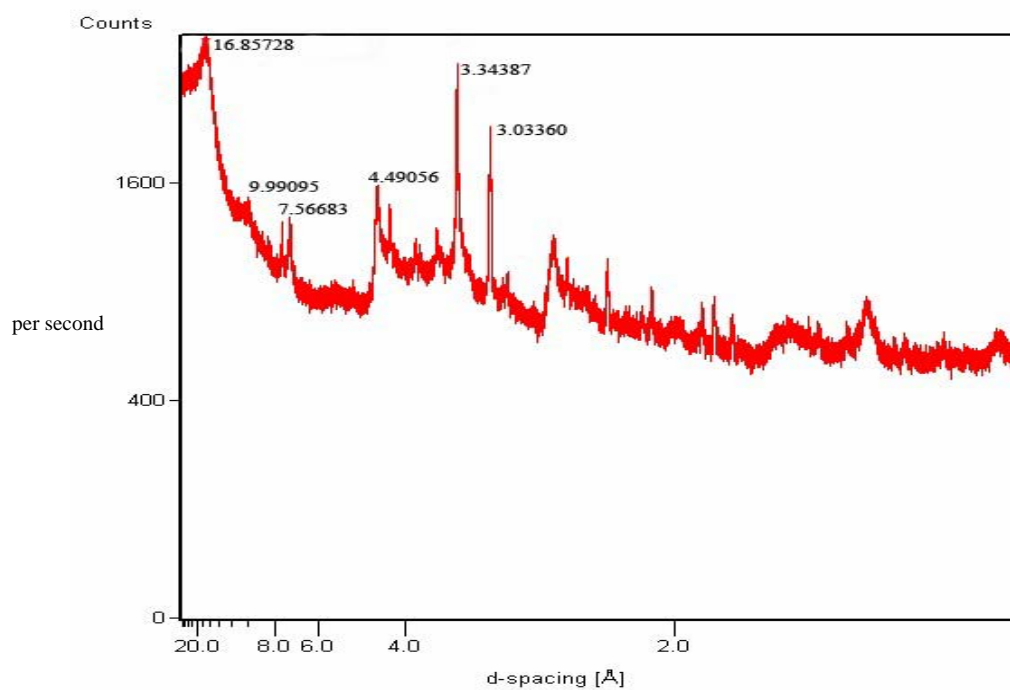
Figure 49: Sample TT\_3\_A, from Feature 6, d-spacing and peaks for identified minerals after ethylene glycol treatment. Note shift in smectite peak.

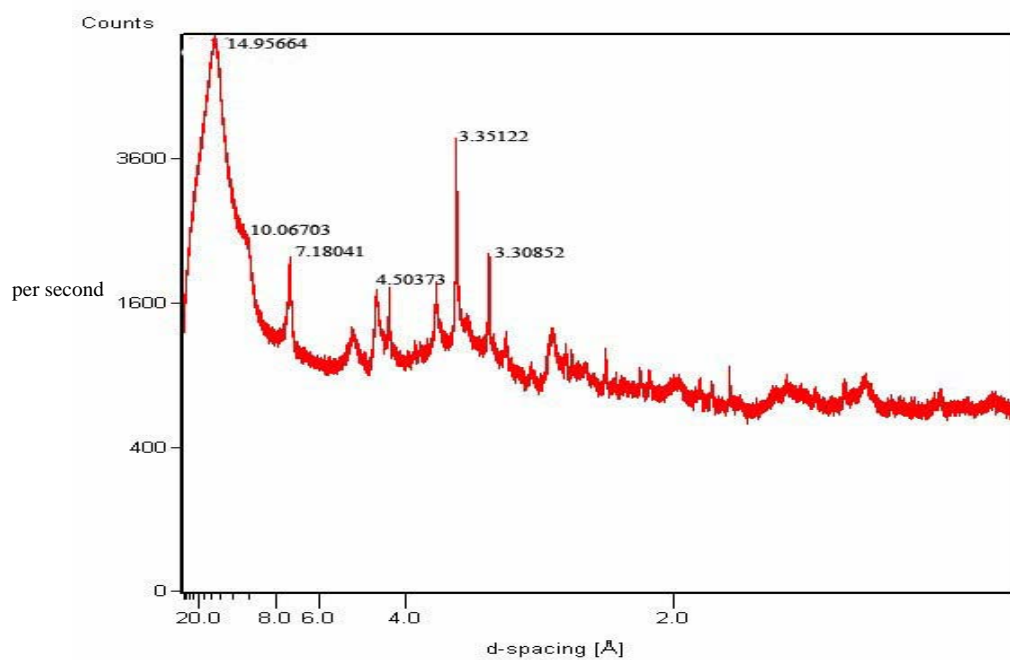
Figure 50: Sample B\_51, from the garage pit, d-spacing and peaks for identified minerals.

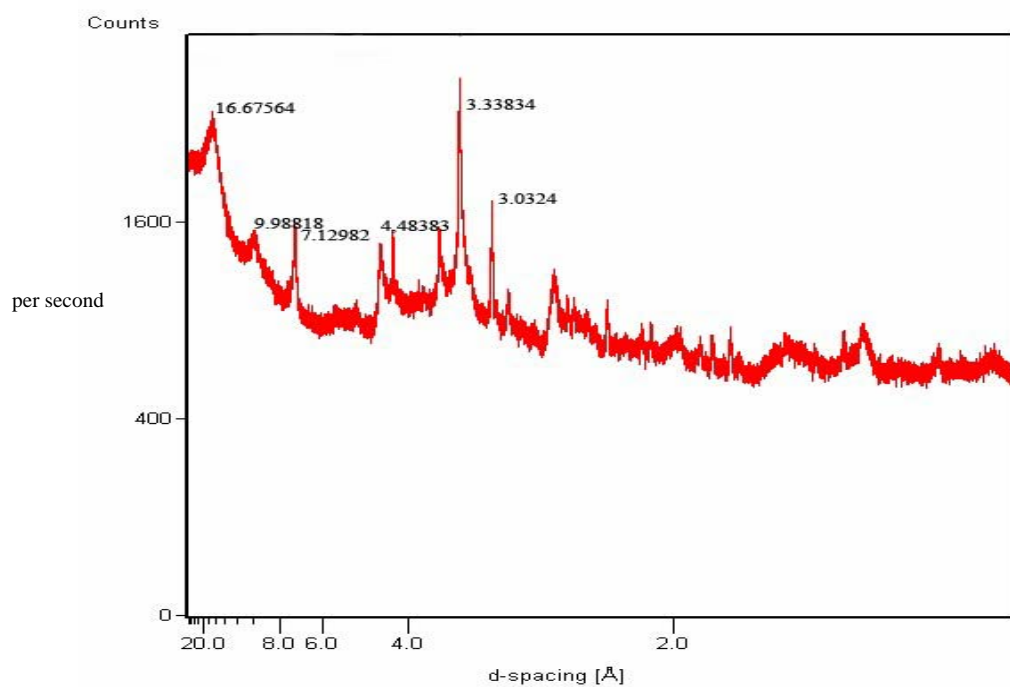
Figure 51: Sample B\_51\_A, from the garage pit, d-spacing and peaks for identified minerals after ethylene glycol treatment. Note shift in smectite peak.

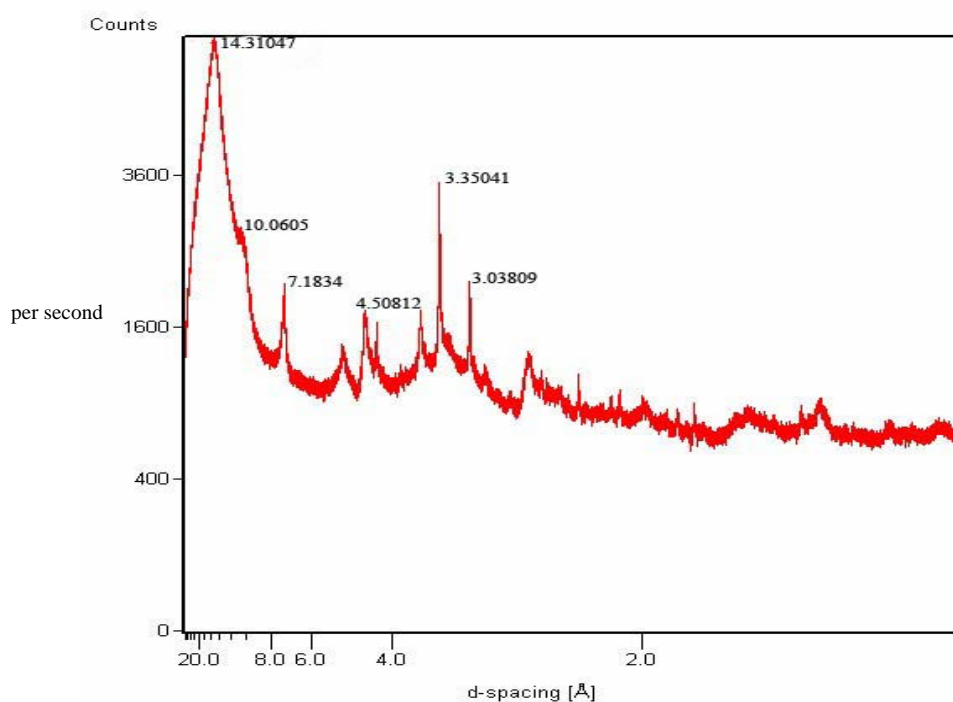
Figure 52: Sample DS\_24, from Test Unit 1 A stratum, d-spacing and peaks of identified minerals.

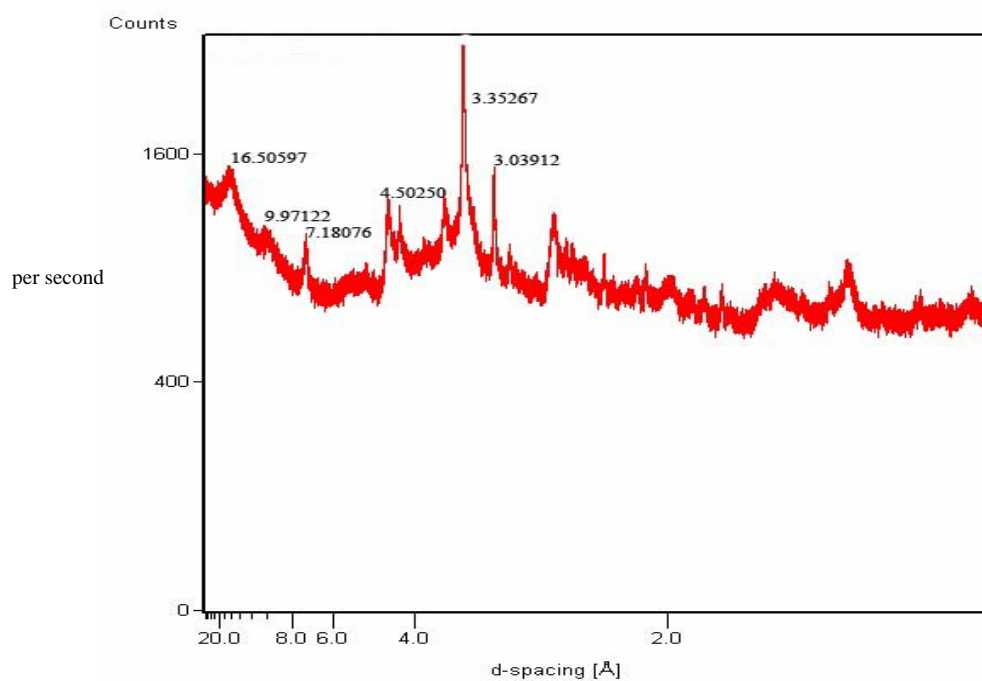
Figure 53: Sample DS\_24\_A, from Test Unit 1 A stratum, d-spacing and peaks of identified minerals after ethylene glycol treatment. Note shift in smectite peak.

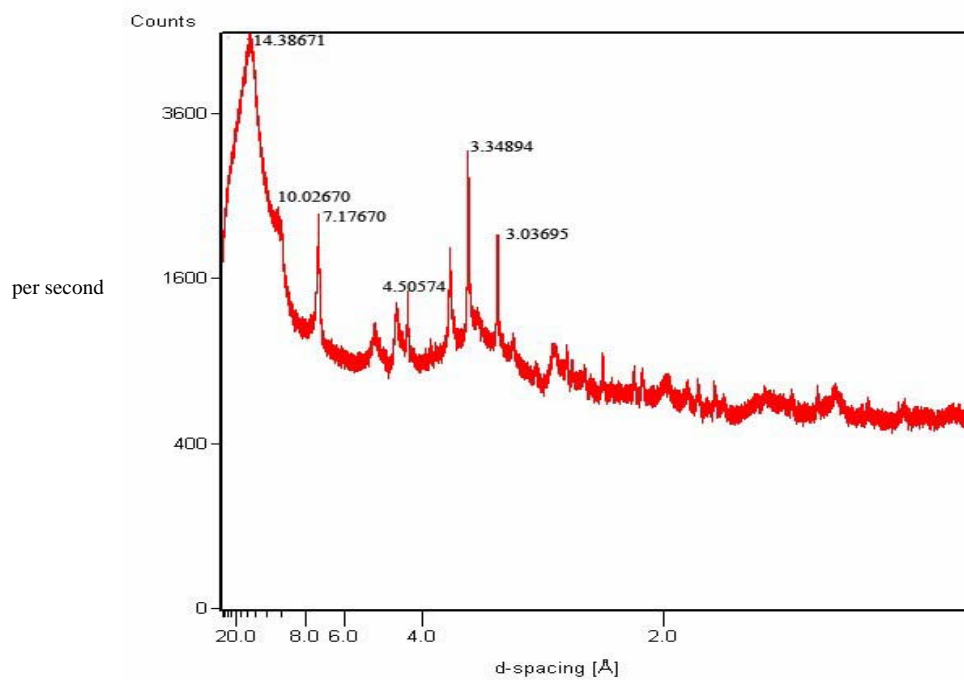
Figure 54: Sample E\_1, from Test Unit 1 C stratum, d-spacing and peaks of identified minerals.

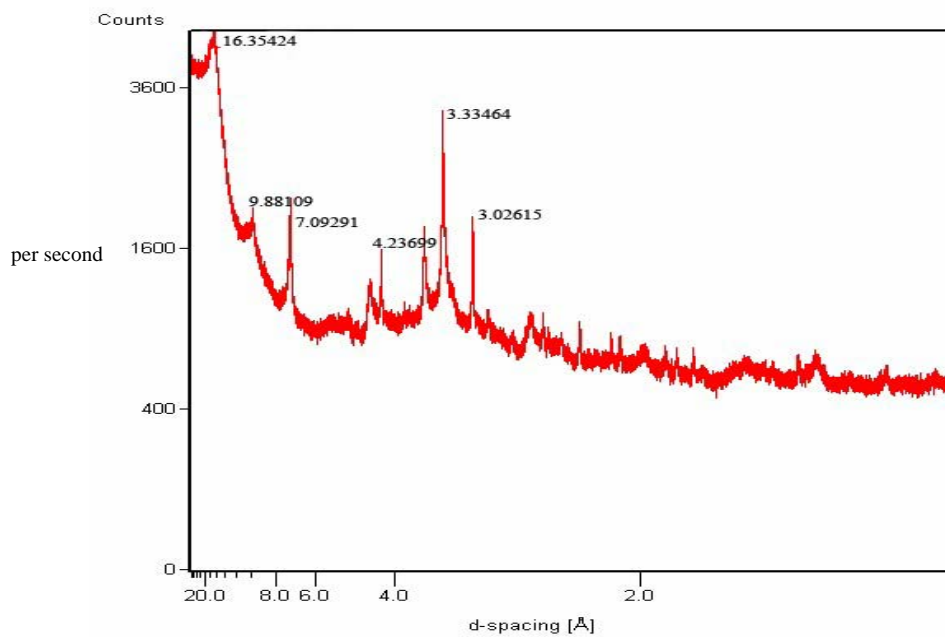
Figure 55: Sample E\_1\_A, from Test Unit 1 C stratum, d-spacing and peaks of identified minerals after ethylene glycol treatment. Notice shift in smectite peak.
